REPORT DOCUMENTATION PAGE		READ INSTRUCTIONS BEFORE COMPLETING FORM
1. REPORT NUMBER Appendix V to the O&M Manual Longview Lake	2. GOVT ACCESSION NO.	3. RECIPIENT'S CATALOG NUMBER

4. TITLE (and Subtitle) Multiple-Purpose Project; Little Blue River Basin Little Blue River, Missouri Longview Lake Operation and Maintenance Manual; Appendix V Embankment Criteria and Performance Report	5. TYPE OF REPORT & PERIOD COVERED Embankment Criteria and Performance Report Sep 79 to Sep 90

9. PERFORMING ORGANIZATION NAME AND ADDRESS Dams and Foundations Section (CEMRK-ED-GD) Geotechnical Branch (CEMRK-ED-G) U.S. Army Corps of Engineers, Kansas City District 601 E. 12th Street, Kansas City, MO 64106	8. CONTRACT OR GRANT NUMBER(s)

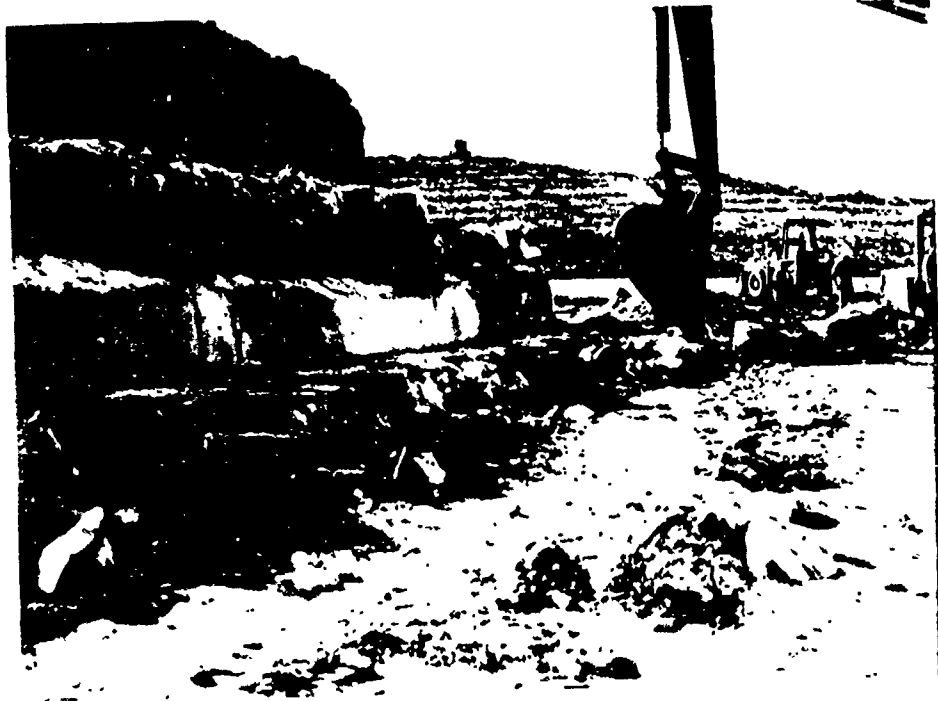
45. 13 September 1983. Upstream right abutment.

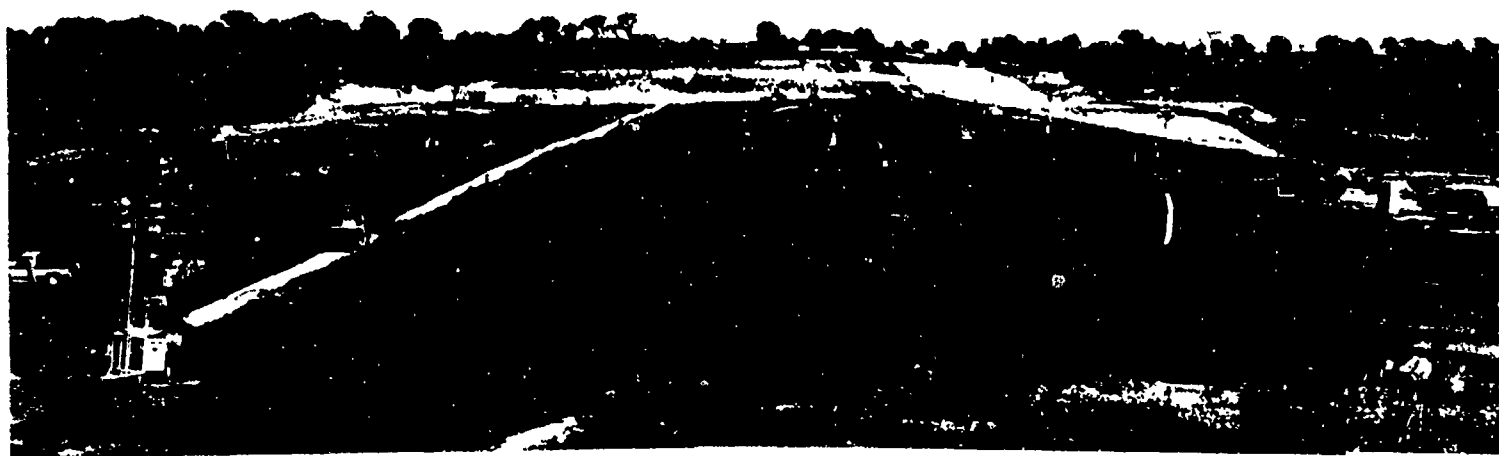
46. 26 October 1983. Fill placement in closure section.
Looking toward right abutment.

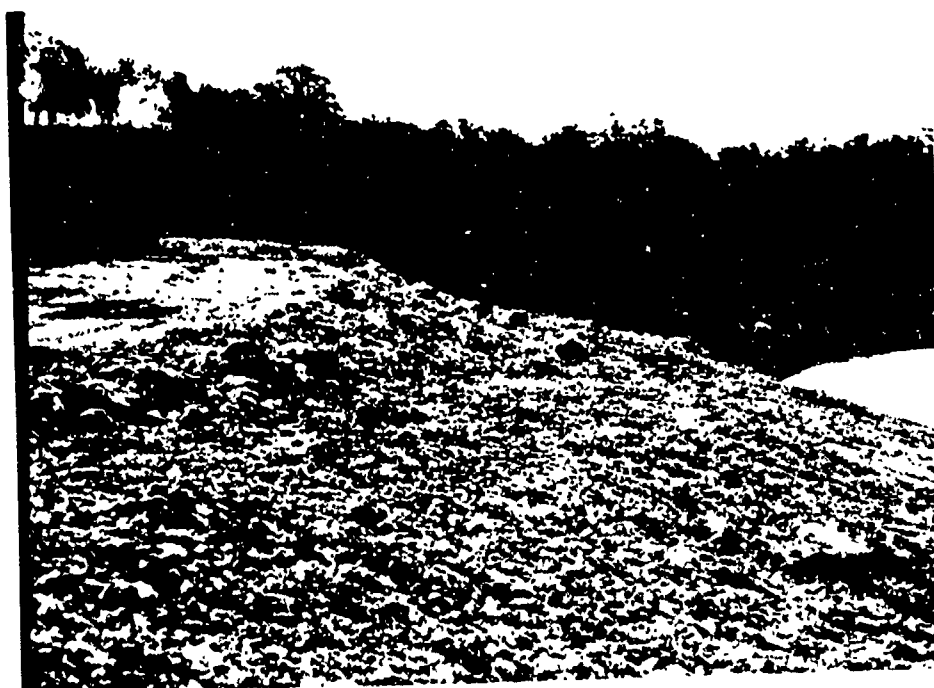
47. 24 May 1984. Rockfill in clay blanket area on upstream
right abutment. Looking upstream.

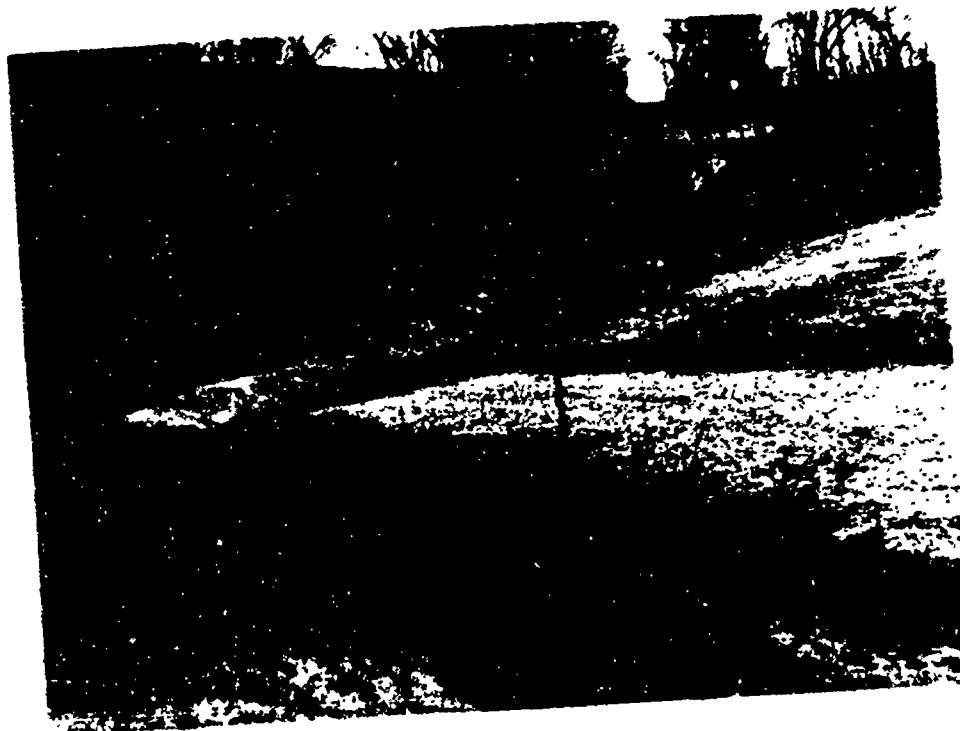
62. 05 March 1986. Downstream right abutment contact showing cleared sewer line alignment at upper left.

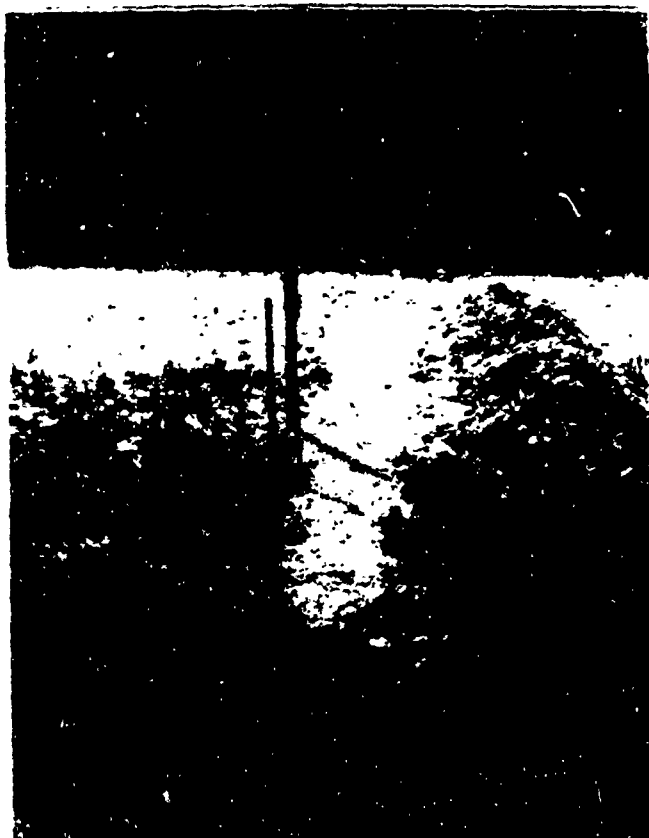
66. 19 May 1986. Completed finger drain installation at embankment toe..
